SpaceX's Starship SN3 prototype cryogenic test fail

Report prepared and published by Texas Steel Inc.

SPACEX'S STARSHIP SN3 PROTOTYPE CRYOGENIC TEST FAIL

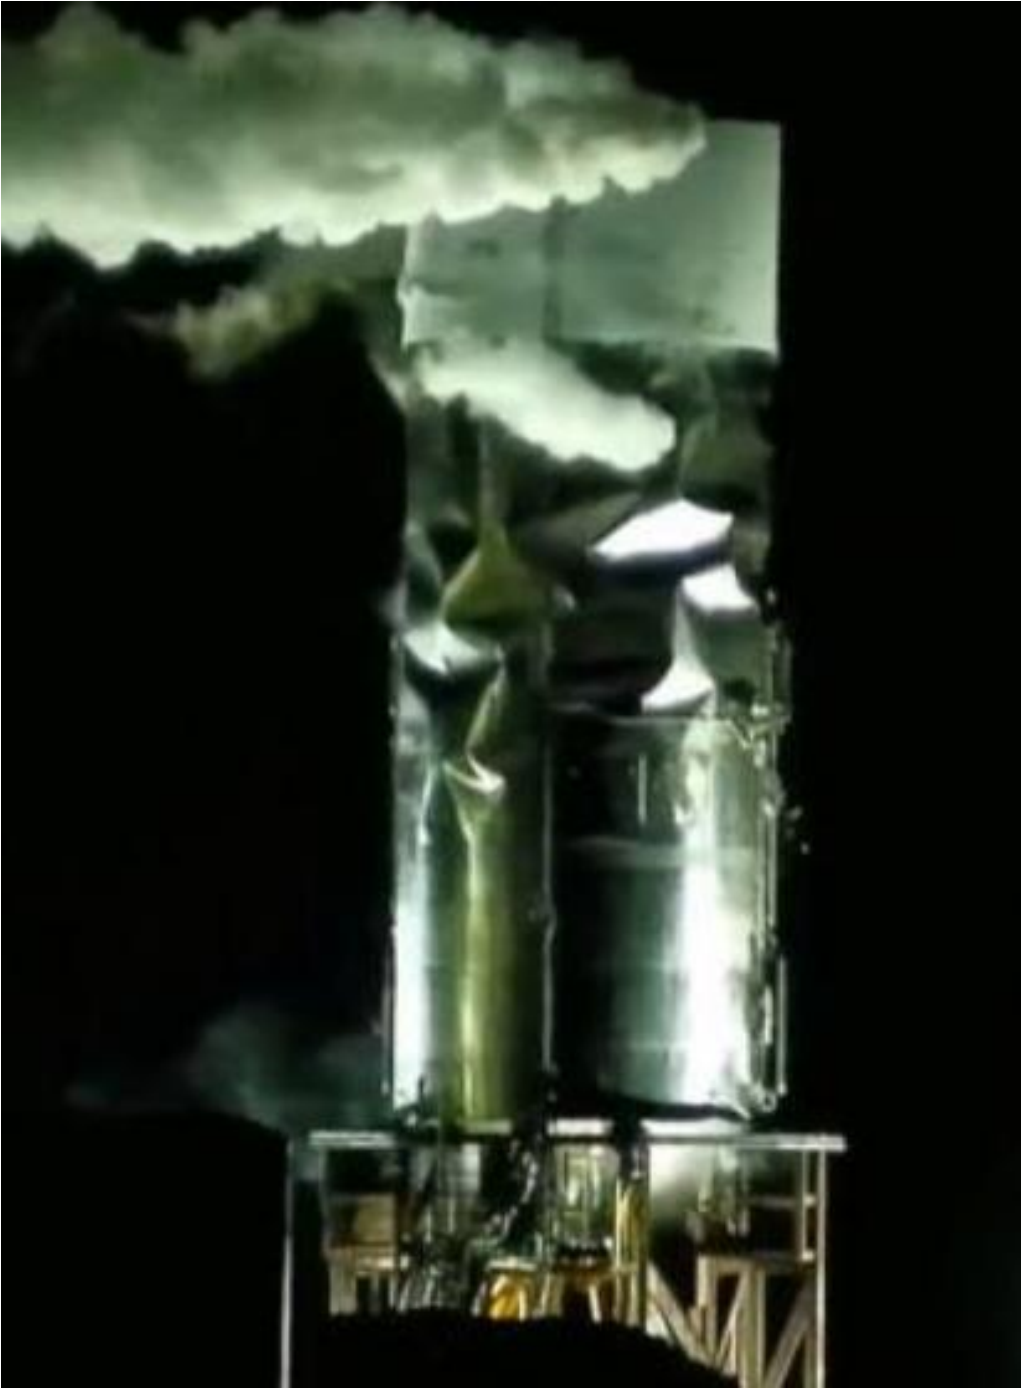
In a videos available publically the unique diamond mode collapse due to compression forces can be seen. Unprecedented to find examples of the phenomena this large. It only happens when the ratio of thickness to radius is in the perfect range. That means, materials and their qualities were at the highest rate.

Most likely this issue occurred because of test configuration error, rather than a design, materials or build mistake. Not enough pressure in the LOX tank ullage to maintain stability with a heavy load in the CH4 tank led to this accident.
